平成22年4月～平成23年3月 BOD平均値 (mg/リットル)

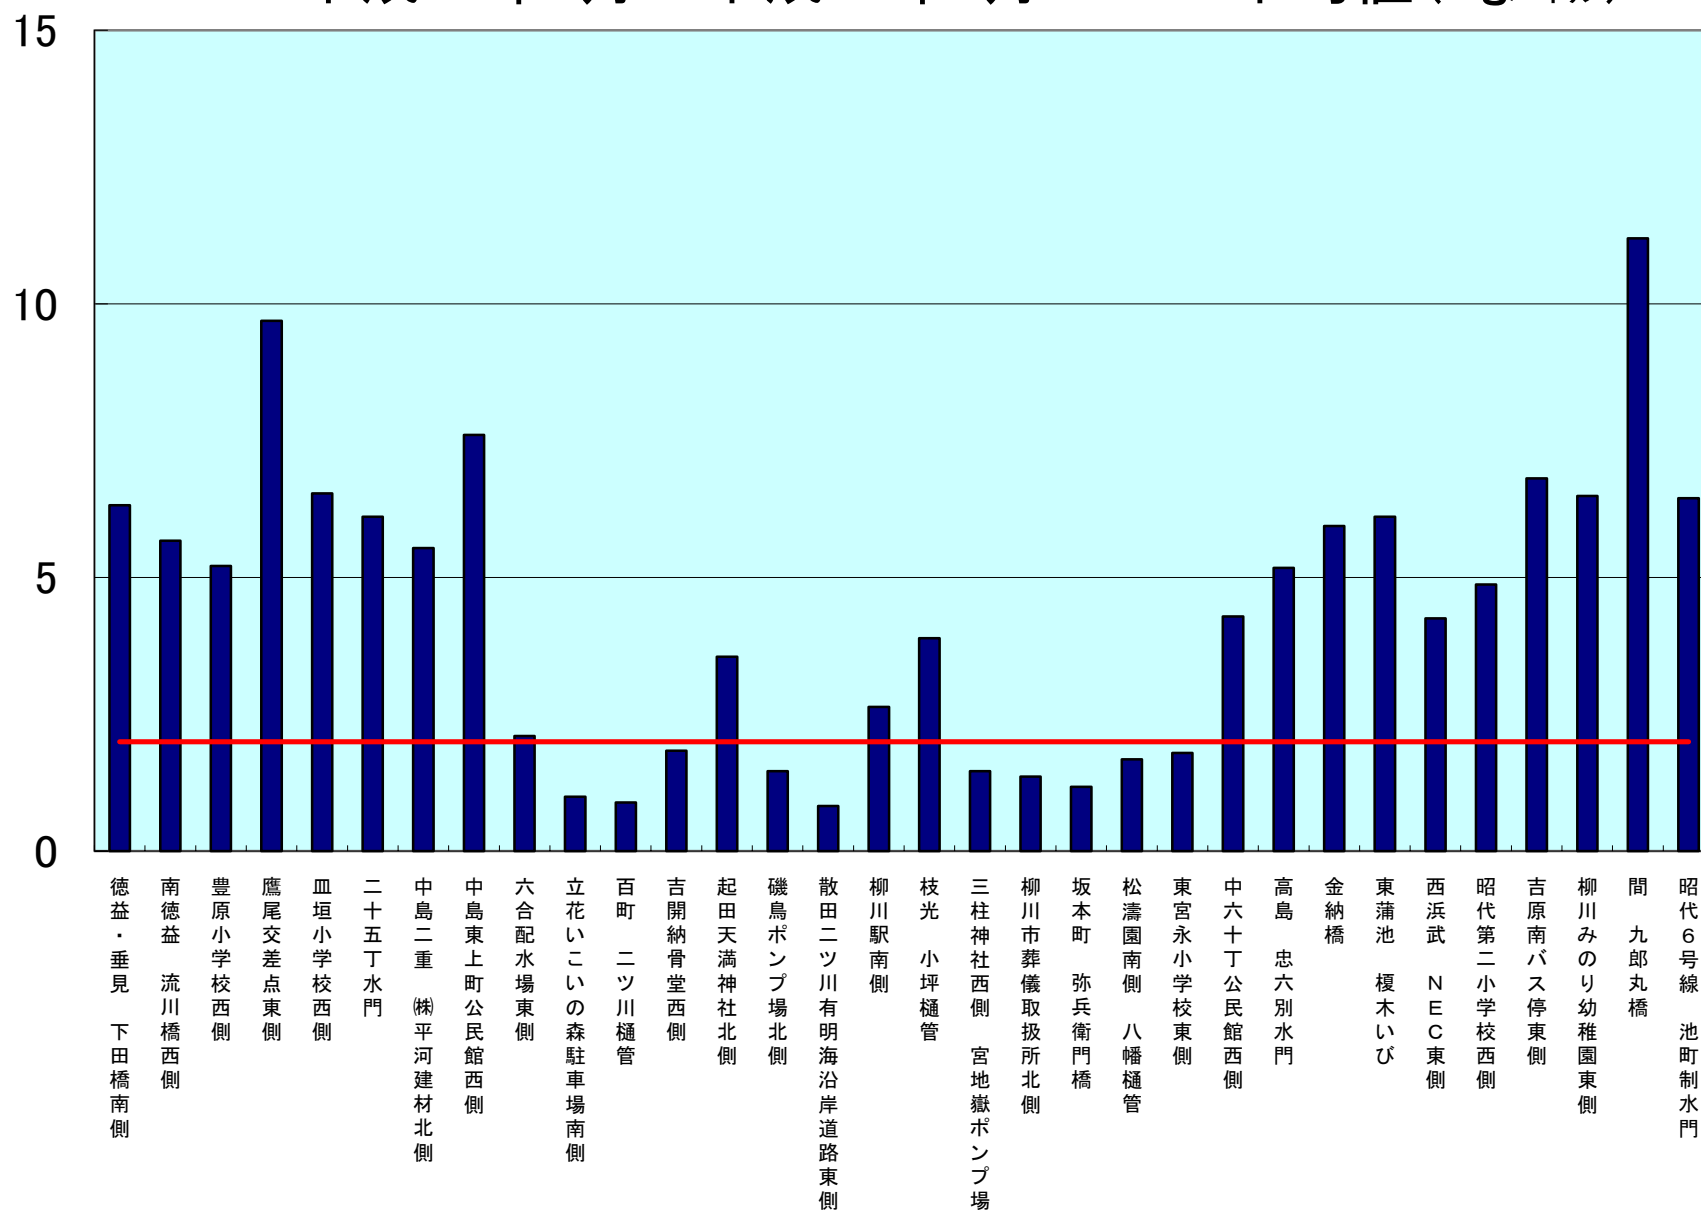
【参考】
環境基準(河川)
A類型: 2mg/リットル
