平成23年4月～平成24年3月 BOD平均値 (mg/リットル)

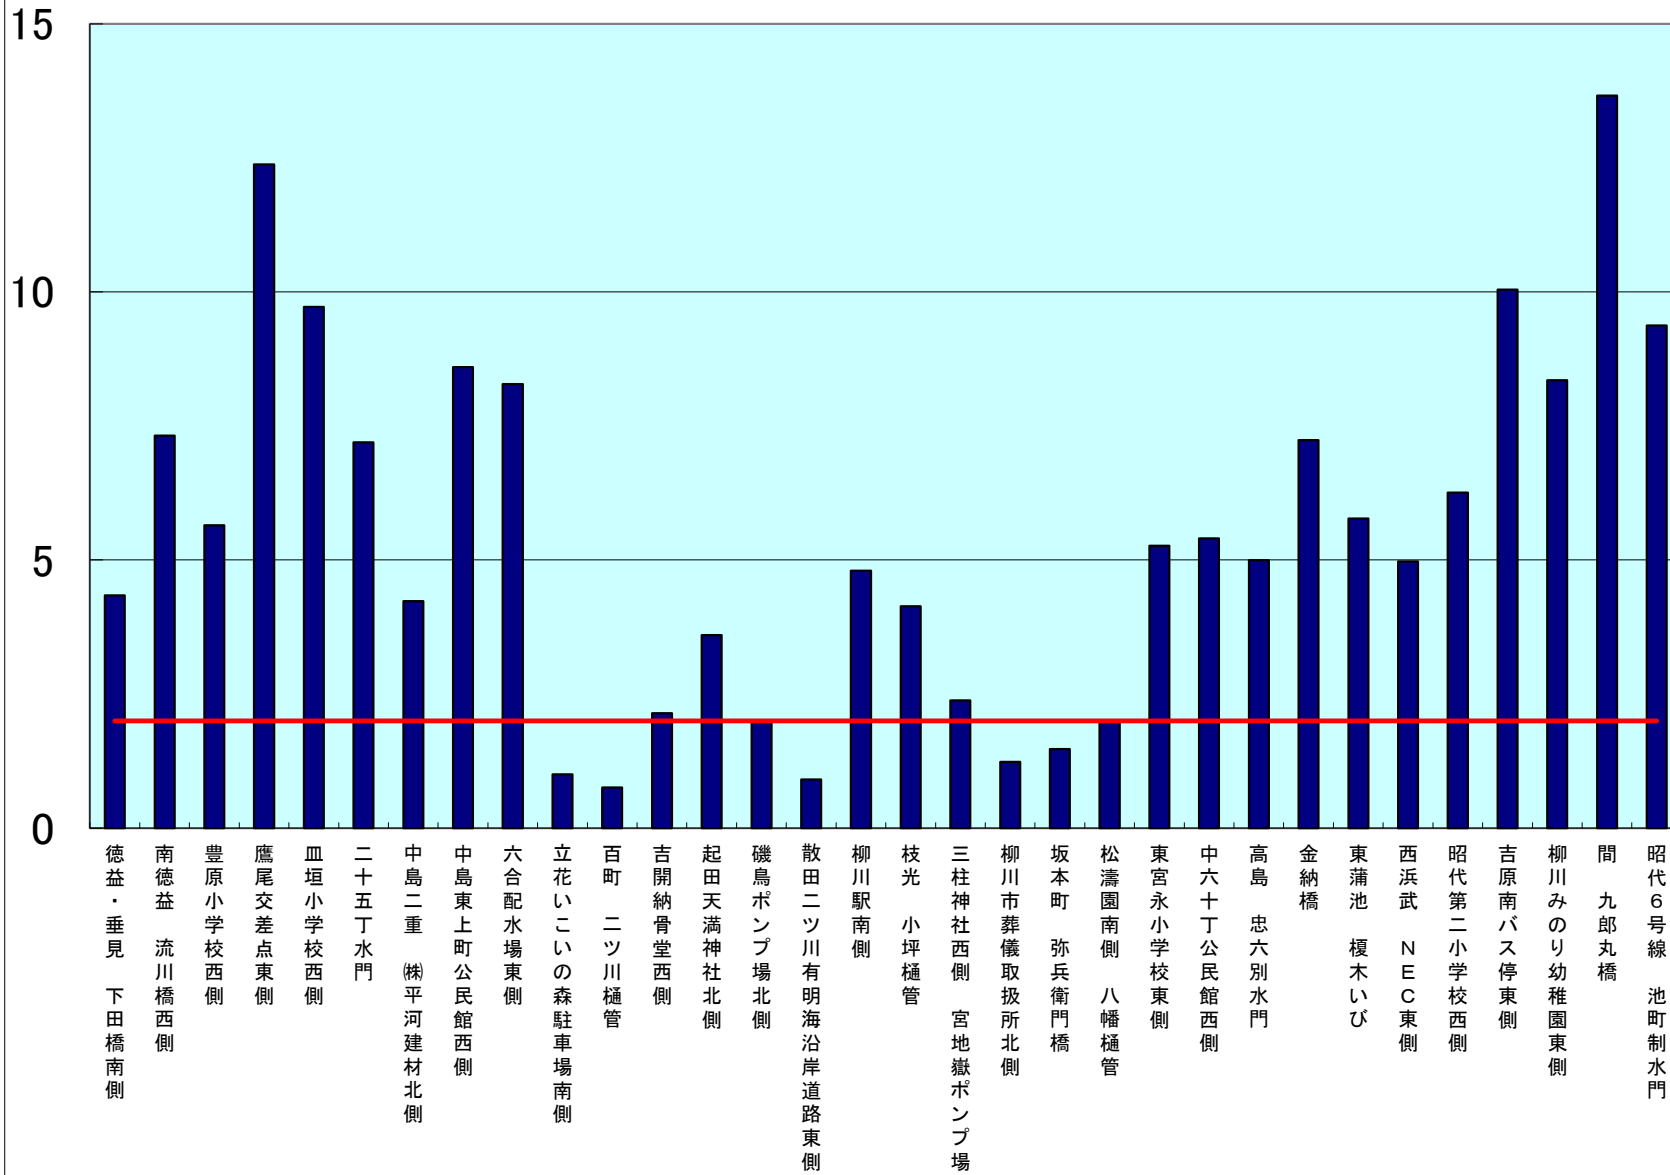
【参考】
環境基準(河川)
A類型: 2mg/リットル
