# 平成30年4月～平成31年3月 平均BOD値(mg/リットル)

平成30年度 BOD(mg/l)測定結果

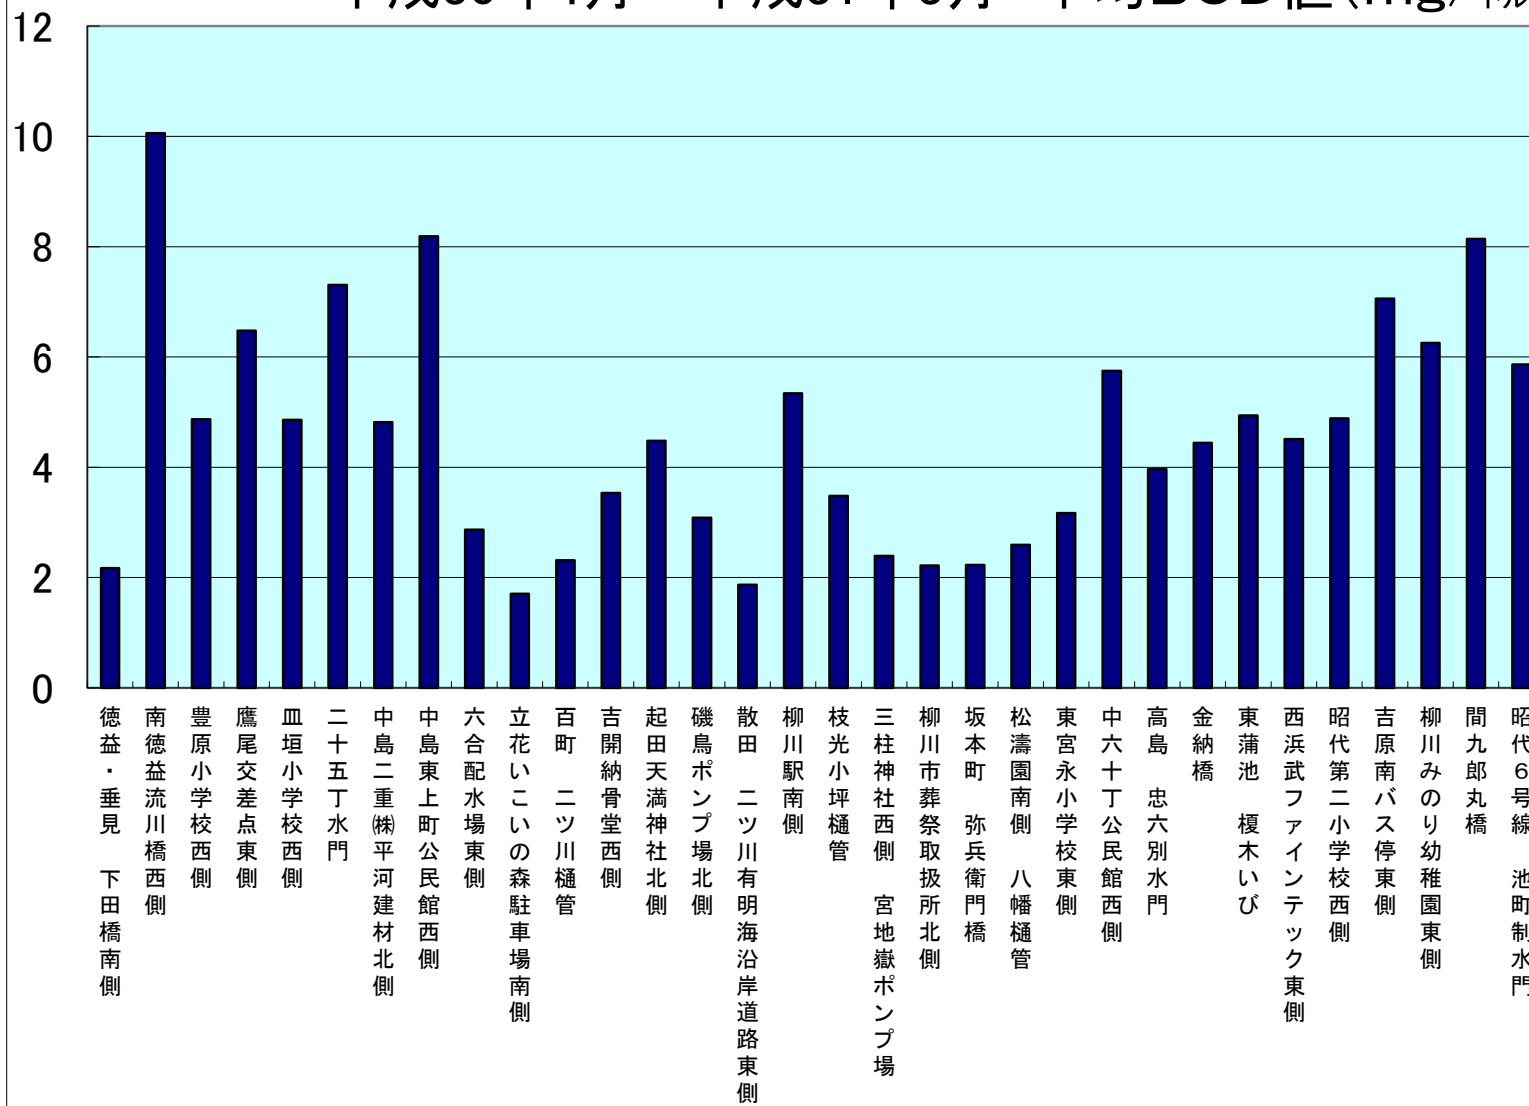
**【参考】**  
 環境基準(河川)  
 A類型: 2mg/L
