# 令和2年4月～令和3年3月 平均BOD値 (mg/リットル)

令和2年度 BOD(mg/l)測定結果

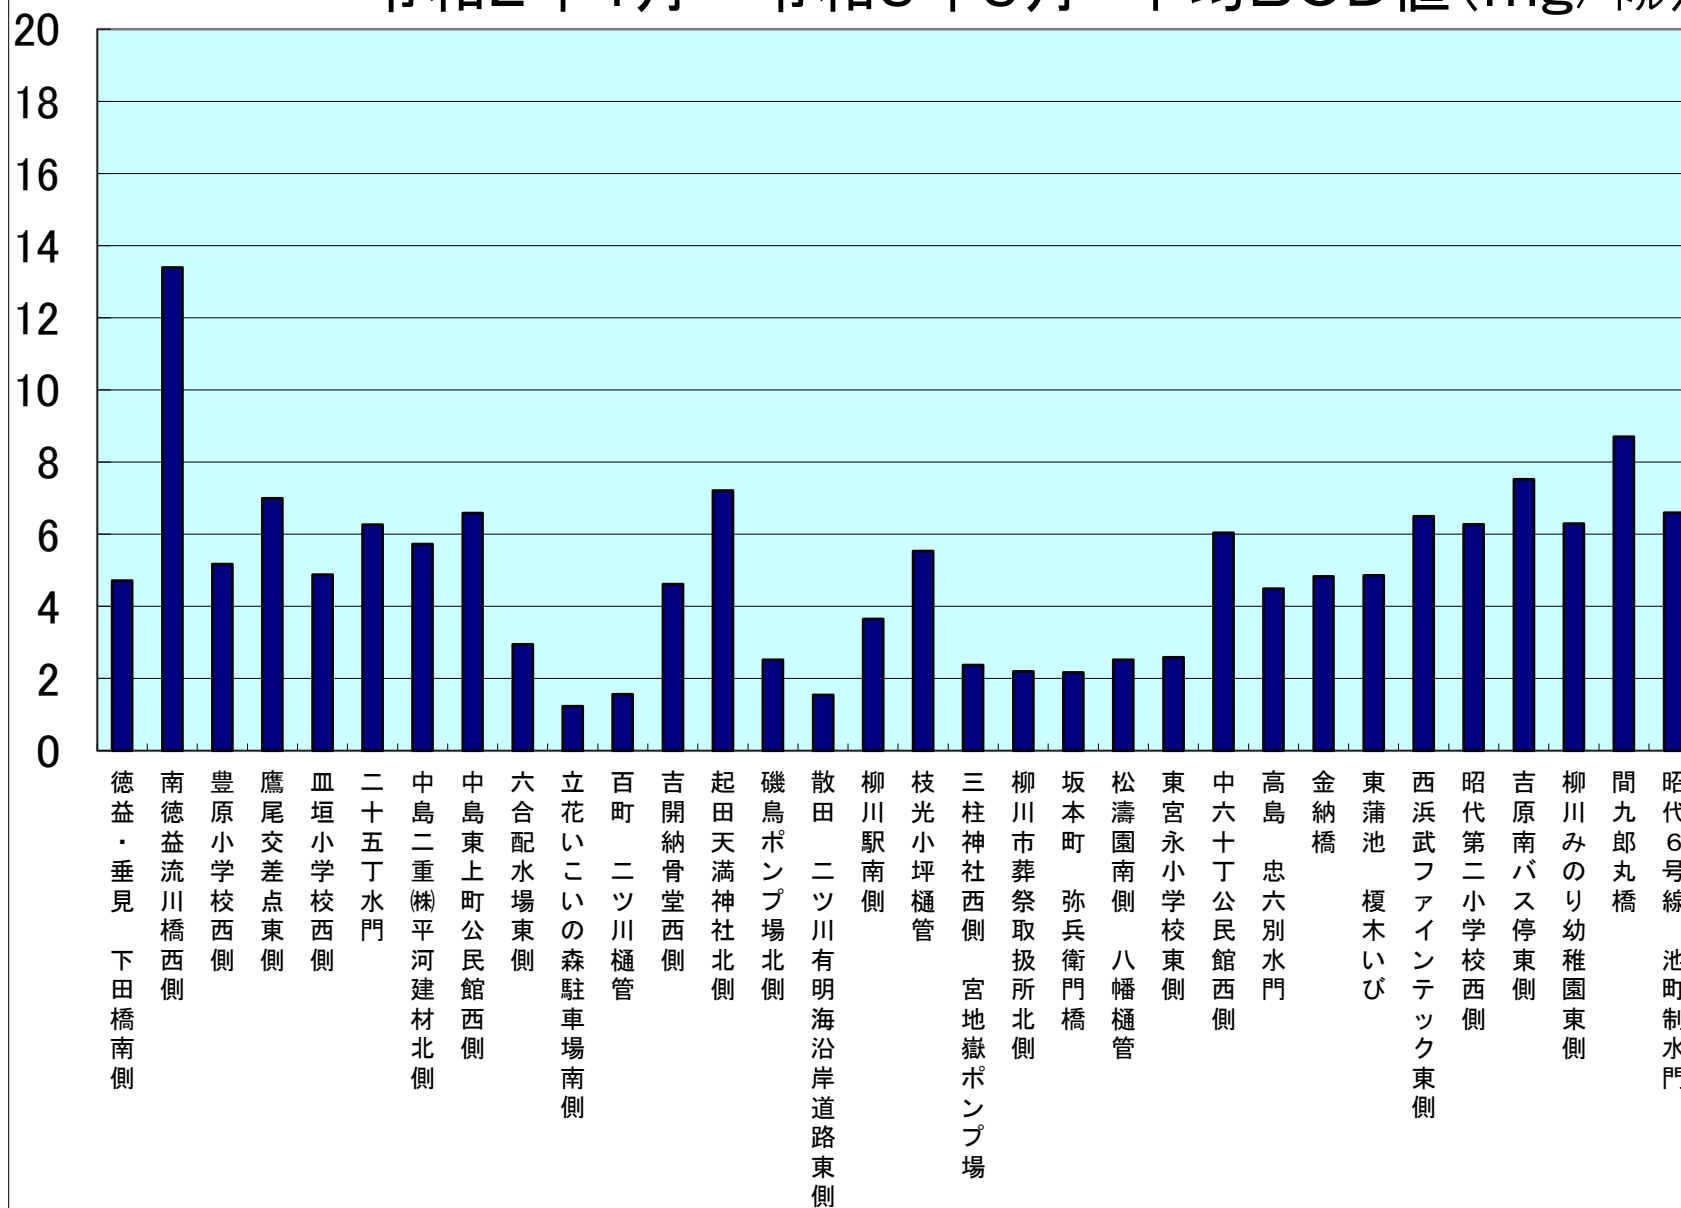
**【参考】**  
 環境基準(河川)  
 A類型: 2mg/リットル
